HISTORIC ARCHEOLOGICAL STUDY

**FORT DES MOINES III
DES MOINES, POLK COUNTY, IOWA**

*Dale R. Henning, Project Archeologist
Barbara Beving Long, Principal Investigator
Four Mile Research Company
315 North Elm Street
Cresco, IA 52136*

1992

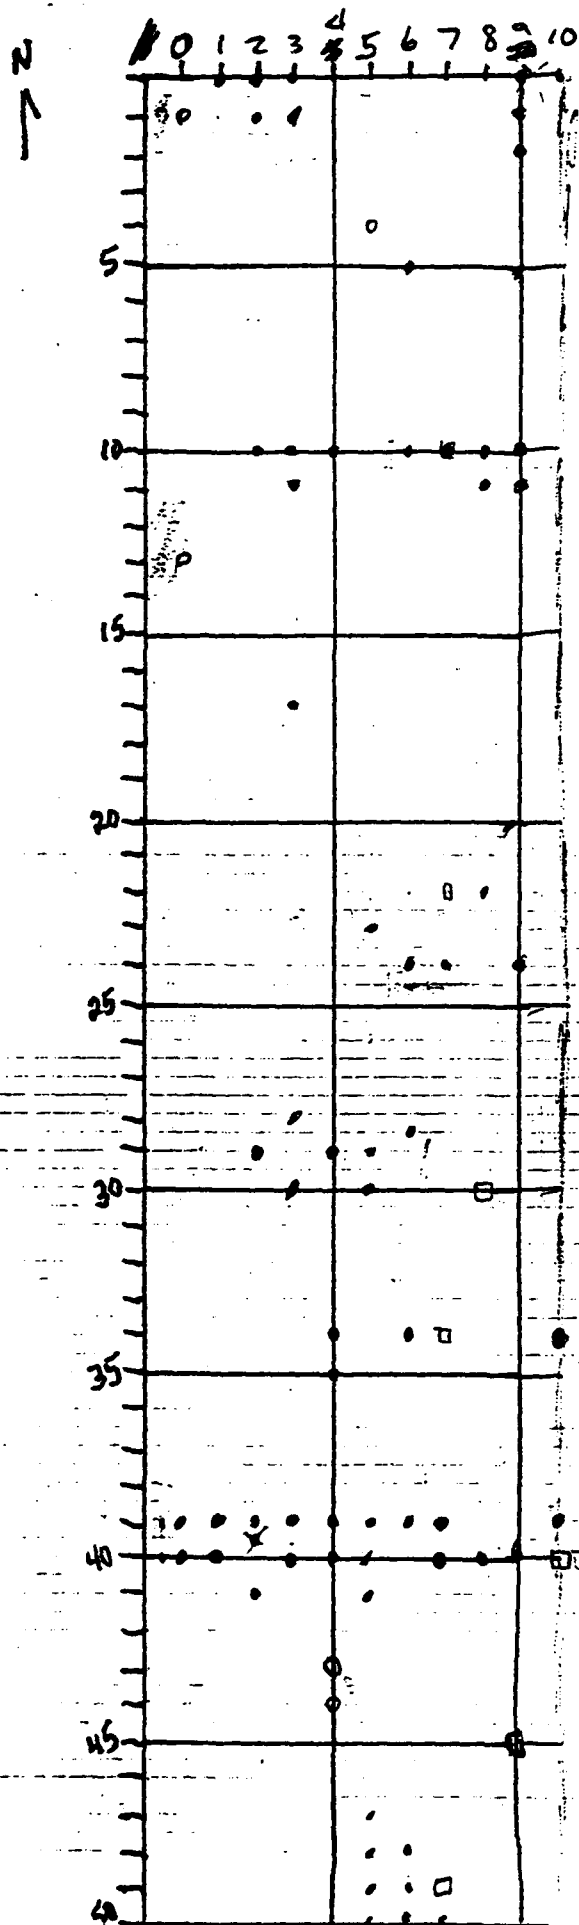
Probe test grid # 1
Steel probe inserted @
meter intervals

no mark = smooth entry
• = gravel-like near
surface
□ = solid feel:
brick, concrete
○ = other (describe)
